## **Service Letter**

Ref. No.: HGS-HSP-SL-19-001

**Subject: The causes of oil leakage on Engine block surface**

**Type : H21/32**

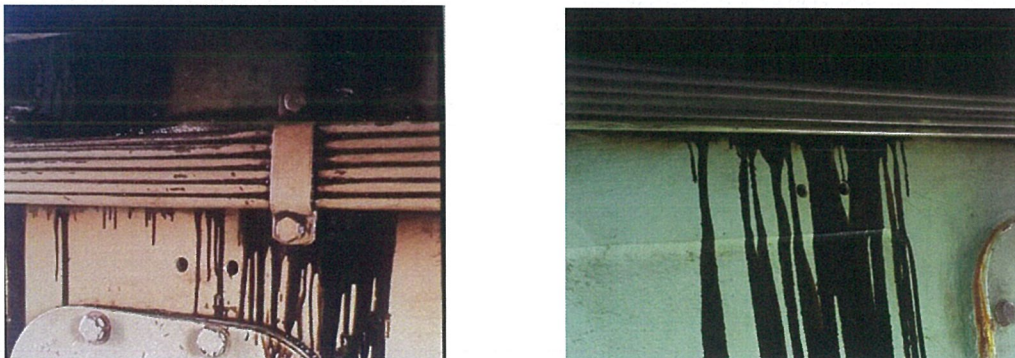
Fig. 1

Recently, we have been reported that oil leaking to the exhaust side of the Engine block. The issue is that the oil leaks in cylinders 4, 5, 6, 7, 8 of Yaguaramas Site #5 Engine. On this issue, Yaguaramas Plant considers the occurrence of steps due to Fretting between the Engine block and the Water jacket as the main reason as shown Fig.1

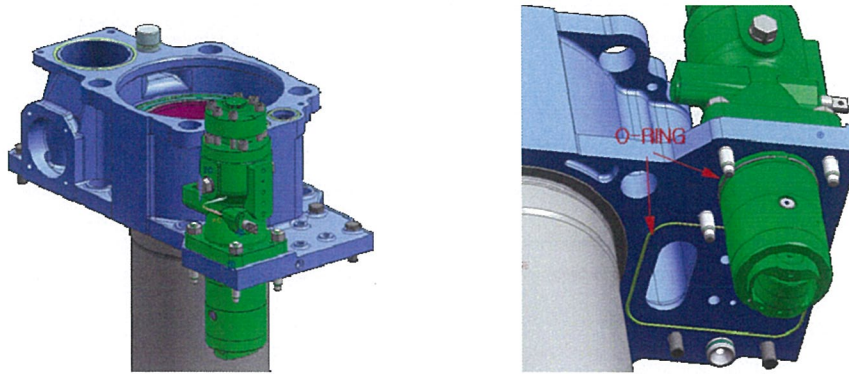
Fig. 2

In the first case, assuming that the LO is leaked, we can estimate the case where two O-rings are damaged as shown in Fig 2. However, the bolt is properly tightened and the two O-rings in the picture below are normal, there is no possibility of LO leakage between the engine block and the jacket contact surface. If LO leakage occurred, it is estimated that

there was obviously an O-ring damage, which is not related to Fretting.

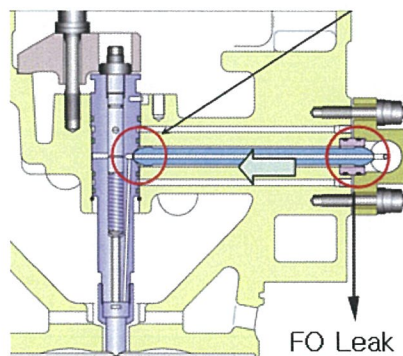
Fig. 3

In the second case, assuming that the FO is leaking, when the HP block is assembled in the cylinder head, the O-ring is caused by damage or poor assembly as shown Fig. 3.

Judging from the results of the design review and field inspections, the oil component of the leaked oil is identified as FO. In order to prevent leakage of the Block surface, it is required to pay attention to the HP block assembly work.
